# **Merrimack Village Dam Final Report: Phase I- Dam Removal Feasibility Study VOLUME 1: Main Report**

***Gomez and Sullivan  
Engineers &  
Environmental Scientists  
55 North Stark Highway  
Weare, NH 03281***

***Pennichuck Water Works  
25 Manchester Street  
PO Box 1947  
Merrimack, NH 03054-1947***

**December 2004**

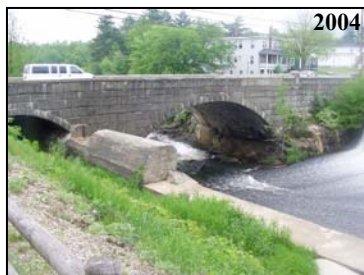
The present day Chamberlain Bridge was constructed in 1921 by the Lovejoy Granite Company of Milford. It is one of the only surviving granite bridges that is straight on one side and curved on the opposite side. The original bridge, built in 1806, was wooden. The granite bridge has a main arch with a 60’2” clear span and a smaller arch that carries a power canal through one spandrel to a former mill on the downstream side. The Merrimack Village Dam (MVD) is located immediately

upstream of the bridge. The bridge was widened on the downstream side in 1934 using curved reinforced concrete, faced with stone to form the original fascia. On July 28, 2003, the State of New Hampshire placed Chamberlain Bridge on the State Register of Historic Places.

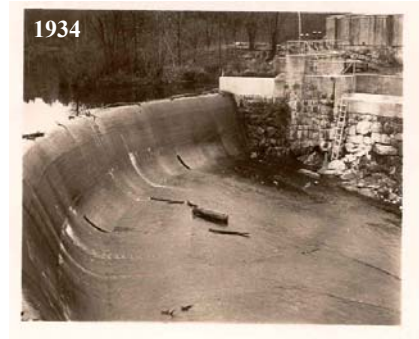
The original dam structure was a gravity stone masonry dam constructed on bedrock outcroppings. According to the NHDES Dam Bureau files the original structure dates to at least 1907<sup>2</sup>. In 1916 the height of the dam was increased, and circa 1934 the spillway was capped with concrete to form the current arched ogee spillway and concrete apron. Evidence of former flashboards can be detected by the existing steel sleeves located every six feet on center across the spillway. Based on the construction dates of the Chamberlain Bridge and the MVD it appears that the dam was constructed before the present day Chamberlain Bridge. This may explain why the smaller arch of Chamberlain Bridge conveniently spans the power canal.

Handwritten correspondence in the NHDES files indicated that the ogee spillway was constructed over the masonry dam to prevent spray from hitting the Chamberlain Bridge and affecting the Route 3 road crossing. The former purpose of the 1934 dam was to generate electricity for leather manufacturing at the International Shoe Company. The most recent purpose of the dam was to provide water to the New England Chemical Company that formerly operated a chemical storage, manufacturing and distribution business in buildings located downstream of the dam (the mill buildings have since been removed). The dam was purchased by PWW in the November 1964 to provide a supplementary water supply, although it was never used.

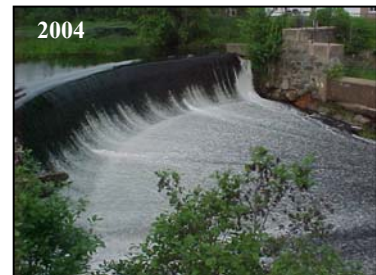
Shown in Figure 4.1-1 is a plan view of the MVD, canal structure, and Chamberlain/Route 3 Bridge. Figures 4.1-2 through 4.1-5 detail the dam cross-section and the canal structure. Shown in Figure 4.1-2 is a scanned cross-section of the former (prior to 1934) dam and proposed (now existing) dam. This figure is a 1934 Highway Department drawing of the original dam crest and the ogee crest currently in place. It should be noted that a complete survey of the dam and canal structures was not conducted. Instead, existing plans from the Army Corps of Engineers and previous Federal Energy Regulatory Commission (FERC) licensing applications were obtained and key elevations were confirmed in the field as part of this study.

The MVD is classified by the NHDES Dam Bureau as a Class A “Low Hazard” dam. According to Env-Wr 101.04 failure of a Class A dam would result in any of the following: a) no possible loss of life, b) minimal economic loss, c) major damage to town and city roads; or d) minor damage to Class I and II state highways.

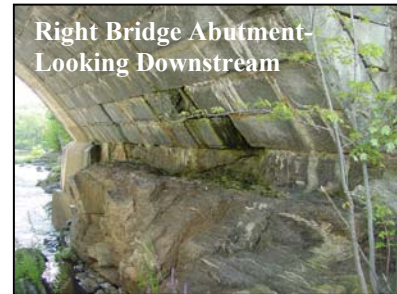
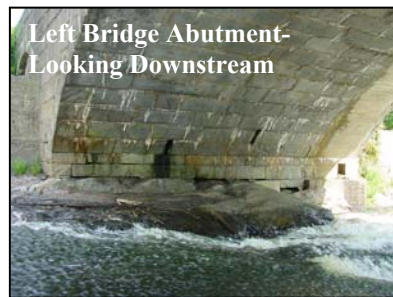
Scour in the channel below the dam is not a significant issue owing to the presence of natural bedrock formations and concrete retaining walls. This is particularly true for the Chamberlain Bridge which has its foundations set upon bedrock (see pictures at left and above). The Chamberlain Bridge would not be affected by abutment scour should the dam be removed. If the impoundment is unprotected, the channel upstream of the MVD will be subject to scour with increased flow velocities upon dam removal. The impoundment will experience a lower water surface elevation as the impoundment reverts to riverine conditions.

Because the sediments in the impoundment are loose deposits of sand and non-cohesive silt/clay, the current channel bed elevation, which is largely determined by impounded sediments, will drop as soil pore pressure decreases in conjunction with receding water-levels. The settling will be augmented by erosion processes that carry loose sediment deposits downstream towards the Merrimack River. Flood water elevations will drop as the channel bed lowers through settling and erosion.

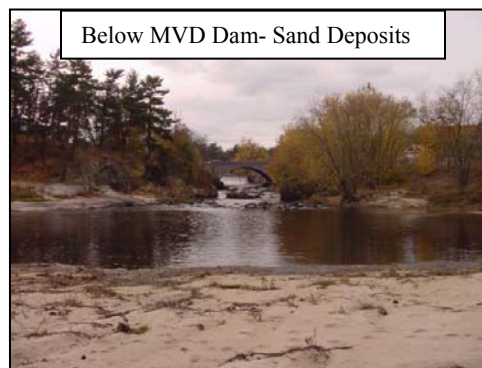
The channel is formed by bedrock overlain with sand and other migrating sediments. Lateral migration of the channel bed will be constrained by channel entrenchment on both banks, though some increase in sinuosity is expected as the channel migrates to attain an equilibrium slope. Slope reduction is accomplished naturally in two ways: 1) incision lowers the channel slope by scouring the channel bed, and 2) migration lowers the channel slope by increasing the length of river between two points. Natural channel stability will be reached as the channel slope is reduced by a combination of the above methods and channel widening.

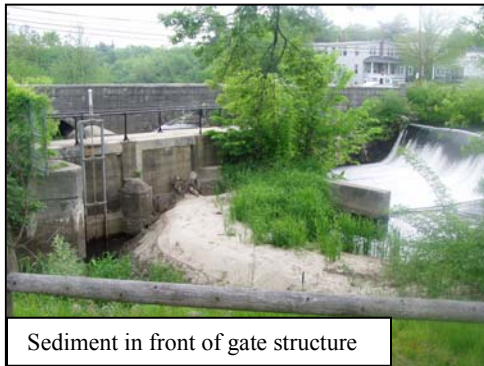
Before removal of the MVD is undertaken, it will be important to initiate several sediment protection-related activities. Investigation of the canal structure and outlet, dredging sediment immediately upstream of the canal gate structure, dewatering of the impoundment, bank stabilization, and revegetation will all need to be initiated or completed before dam removal can begin.

The stoplog gate and sluice gate that act as low-level outlets for the MVD are blocked by as much as 12 feet of sand. Sediment was removed from this location in 1991 when the sluice gate was installed but has been deposited over the past 13 years to the extent that an island of sand nearly 2 feet above the water surface has been deposited in the same location. Sediment has also been deposited in the canal to a depth of nearly 3 feet. Before the impoundment can be dewatered, the sediment from behind the canal gate structure must be removed. As noted earlier, the sediment chemical analysis and subsequent toxicity testing indicates that contaminants are not likely to be readily bioavailable and pose no risk to downstream ecosystems. Thus, preference is given to allow natural transport of sediments within the impoundment.
